**INFLUENCE OF SUBSURFACE DEFECTS ON FATIGUE  
PROPERTIES OF TITANIUM ALLOYS**

UNITED TECHNOLOGIES CORPORATION  
Pratt & Whitney Aircraft Group  
Government Products Division  
West Palm Beach, Florida 33402

Technical Report AFML-TR-77-112  
Final Technical Report for the Period 1 March 1975  
Through 1 March 1977

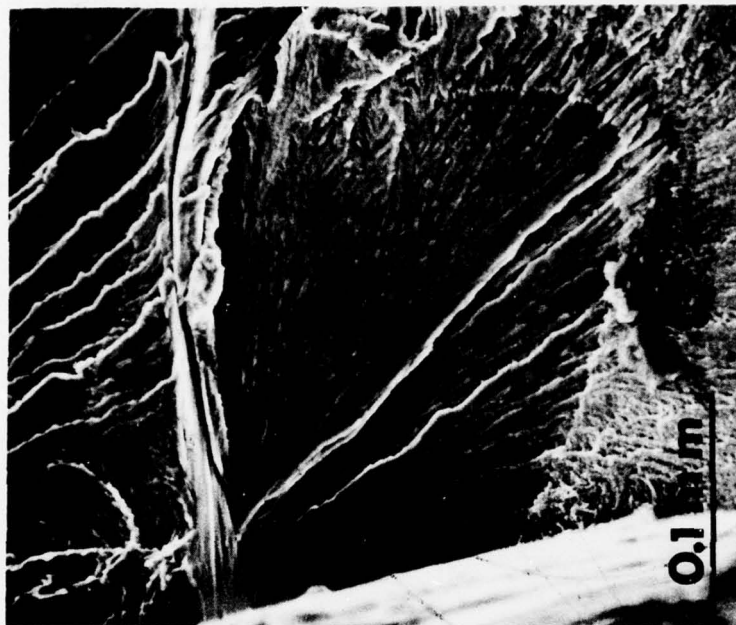
Figure 15 Scanning Electron Micrographs Showing the Appearance of the Subsurface Crack Nucleation Site Indicated in Figure 14b.

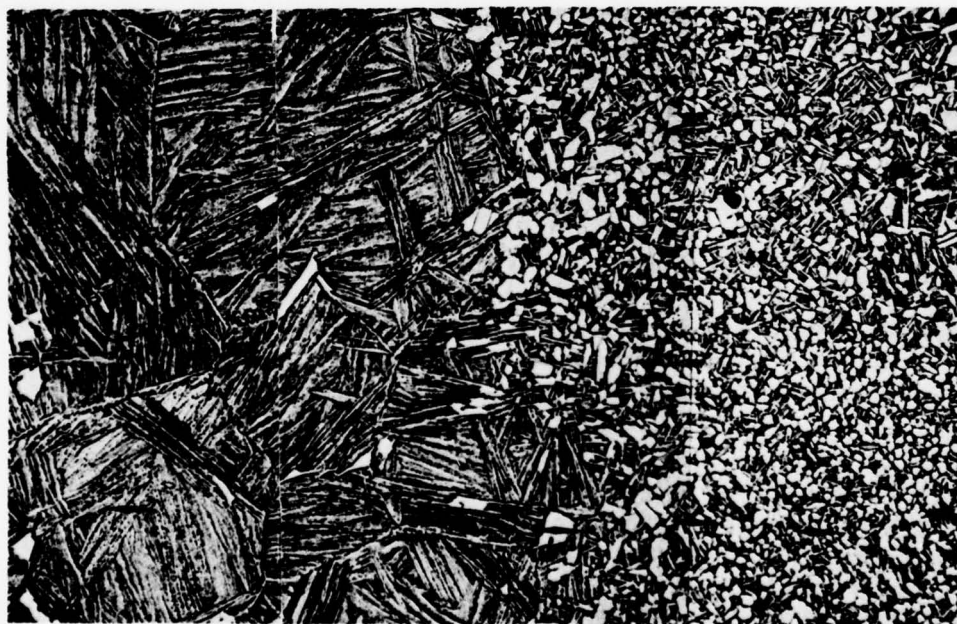
Figure 30 The Microstructure Shown in Figure 29 After Additional Recrystallization Treatment at 1830°F for 1 Hour.

\*See Figure 30

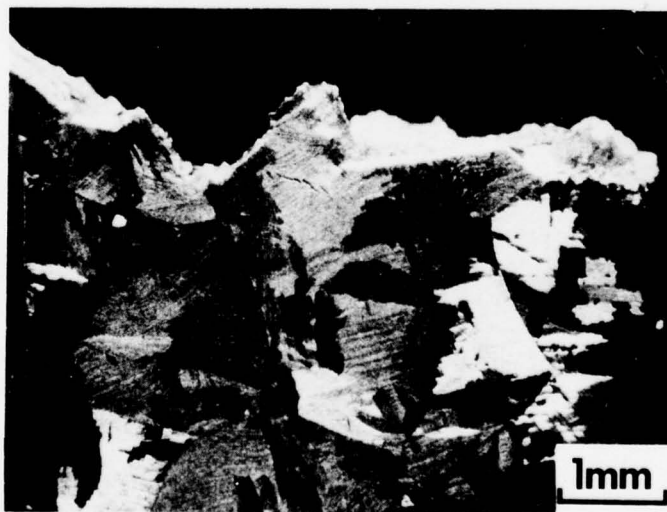
Figure 31 (a) General Appearance of the Fracture of Specimen No. 49 Tested at 400°F. The apparent fracture origin is indicated by an arrow.  
(b) A Longitudinal Section Along the Line Indicated in (a), Showing the prior  $\beta$  grain size adjacent to the fracture surface.

All short life specimens failed from subsurface origins which did not appear to show the characteristic features of a rosette-type failures observed in room temperature tests. A typical fracture for a defect-containing specimen is shown in Figure 31a in which the apparent fatigue origin is indicated by an arrow. It can be seen that the scale of the cleavage facets are much larger than those observed in tests at 70°F. A longitudinal section of the fracture surface, shown in Figure 31b, shows that the cracks cut across several colonies within a prior beta grain. In fact the facet size appears to be set by the latter microstructural dimension.

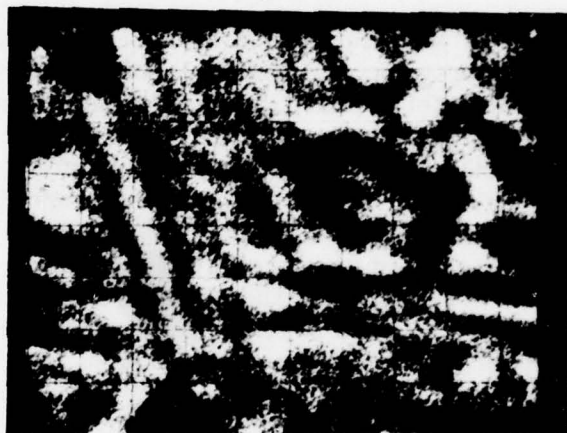
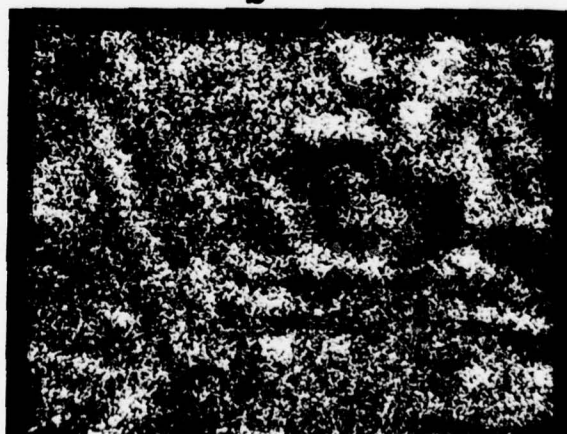
**Figure 58** (a) 51 V Image of a Normal Area  
 (b) 51 V Image of a Beta-Flecked Area  
 (c) 56 Fe Image of a Beta-Flecked Area

The compositions that were measured after sputtering for 15-30 minutes are given in Table 22. The segregation pattern of the alpha stabilizing and beta stabilizing elements in the normal and beta-flecked regions is not clear using this technique. The beta-flecked region contains a higher concentration of beta stabilizing Fe and a lower concentration of alpha stabilizing C. On the other hand, the normal region contains higher concentrations of H and Cr both of which are beta stabilizers. The other elements present appear to be due to residual contamination. Selected secondary ion images are shown in Figure 58. In Figure 58a and b the light areas correspond to the beta phase while the dark area corresponds to the alpha phase. It appears from Figure 4b that the change in V concentrations between alpha and beta phases is a gradual one. Similar observations can be made on Fe (Figure 58c).
